# Successful Stainless Swimming Pool Design

by Catherine Houska, CSI and James Fritz, Ph.D  
(Extracted from Construction Specifier Magazine, December 2005)

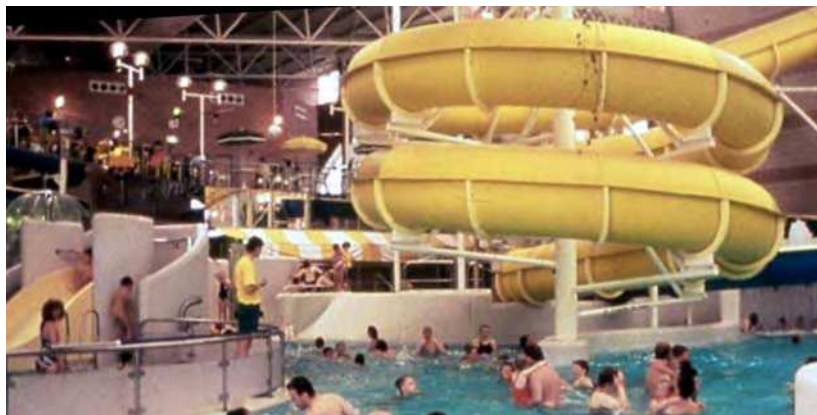
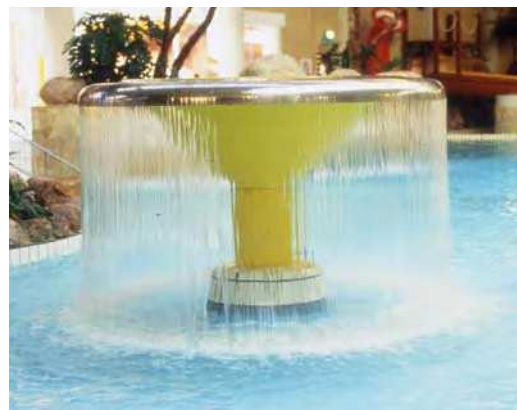
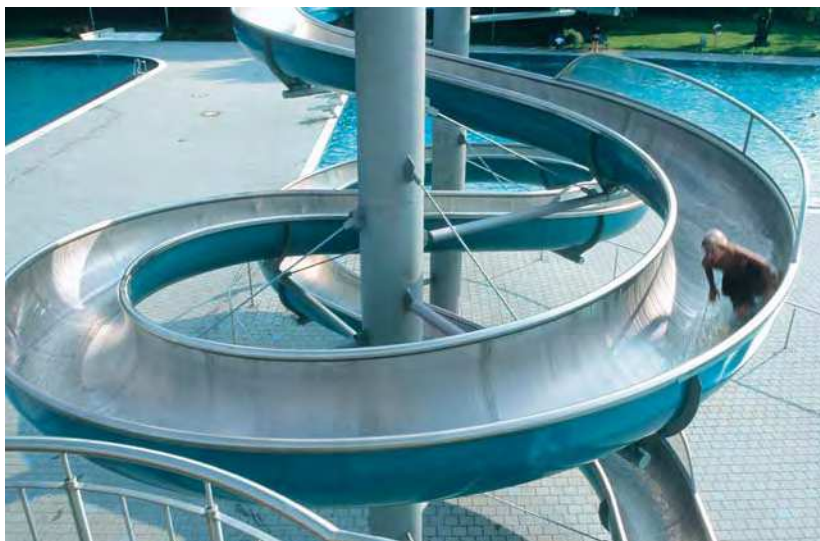
Figure 1

Figures 1, 2 and 3: Stainless steel swimming pool slide and water feature.

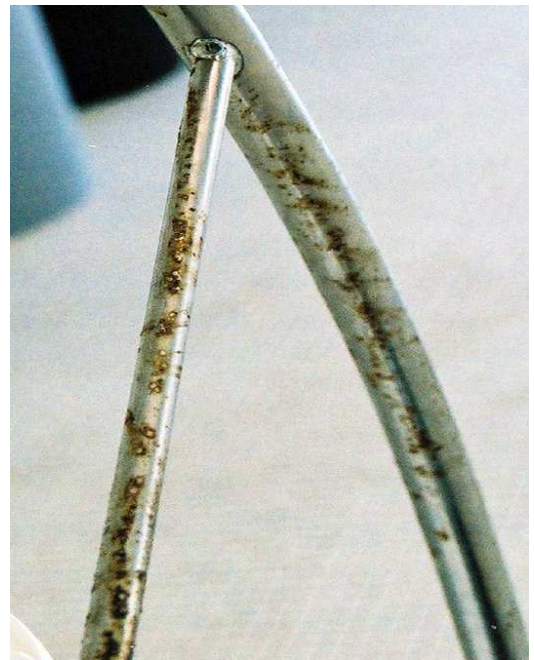
**Figure 4:** This chrome plated carbon steel reel for holding lane markers has only been in use for a few years but there has already been substantial corrosion under the plating. Photo Courtesy of TMR Consulting.

Other less corrosion resistant metals are sometimes used in swimming pool applications. The relative installed cost of aluminum is lower and the corrosion of aluminum components is often overlooked because its corrosion product is white to whitish-gray in appearance. The significantly higher corrosion rate of aluminum in chloride-containing environments makes inspection important so that metal corrosion loss and structural integrity can be determined. Relatively low cost painted and plated carbon steel are sometimes used for pool applications, but their performance is dependent on coating quality and maintenance. Once the protective coating or plating starts to fail, there can be rapid corrosion and structural deterioration of the carbon steel making careful regular inspection and recoating necessary.

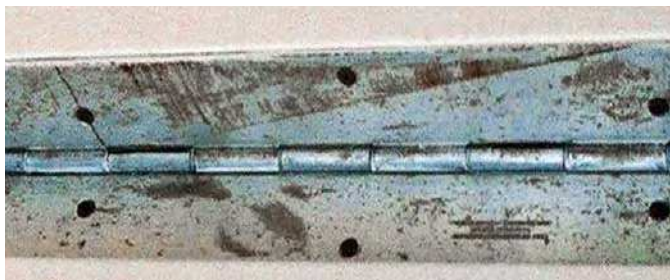
**Figure 5:** Carbon steel brushes were used by a cleaning contractor on this stainless steel door hinge that was installed beside an indoor swimming pool. The areas with carbon steel contamination are rusting. Photo courtesy of TMR Consulting

Poor maintenance and the use of inappropriate cleaning compounds can be another factor in corrosion performance. Carbon steel wool and wire brushes should never be used for cleaning or 'refinishing' stainless steel since particles can become embedded in the surface. These carbon steel particles corrode at the same rate as unprotected carbon steel and cause unsightly surface damage.

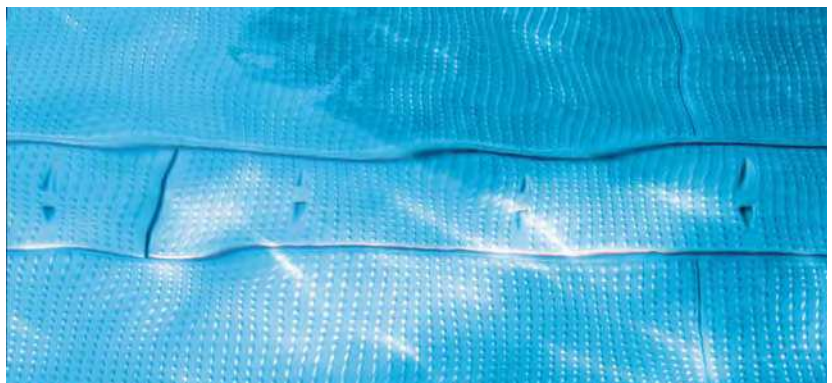
**Figure 10 and 11:** Type 316 pool gutters and water jet openings in the floor plates. Photos courtesy of Martina Helzel
